Re: **Bradbury Stamm / Morningstar of Santa Fe, Construction Stormwater; SIC 1522; NPDES Compliance Evaluation Inspection; NPDES #NMR1000QP; October 25, 2017**

NPDES Compliance Inspection Report

NPDES Construction General Permit Inspection Report – State of New Mexico

On October 25, 2017, a Compliance Evaluation Inspection (CEI) was conducted at the Morningstar of Santa Fe construction site, operated by Bradbury Stamm as the General Contractor under USEPA Construction General Permit (CGP) Notice of Intent (NOI) tracking number NMR1000QP by Sarah Holcomb and Jennifer Foote of the State of New Mexico Environment Department (NMED), Surface Water Quality Bureau (SWQB).

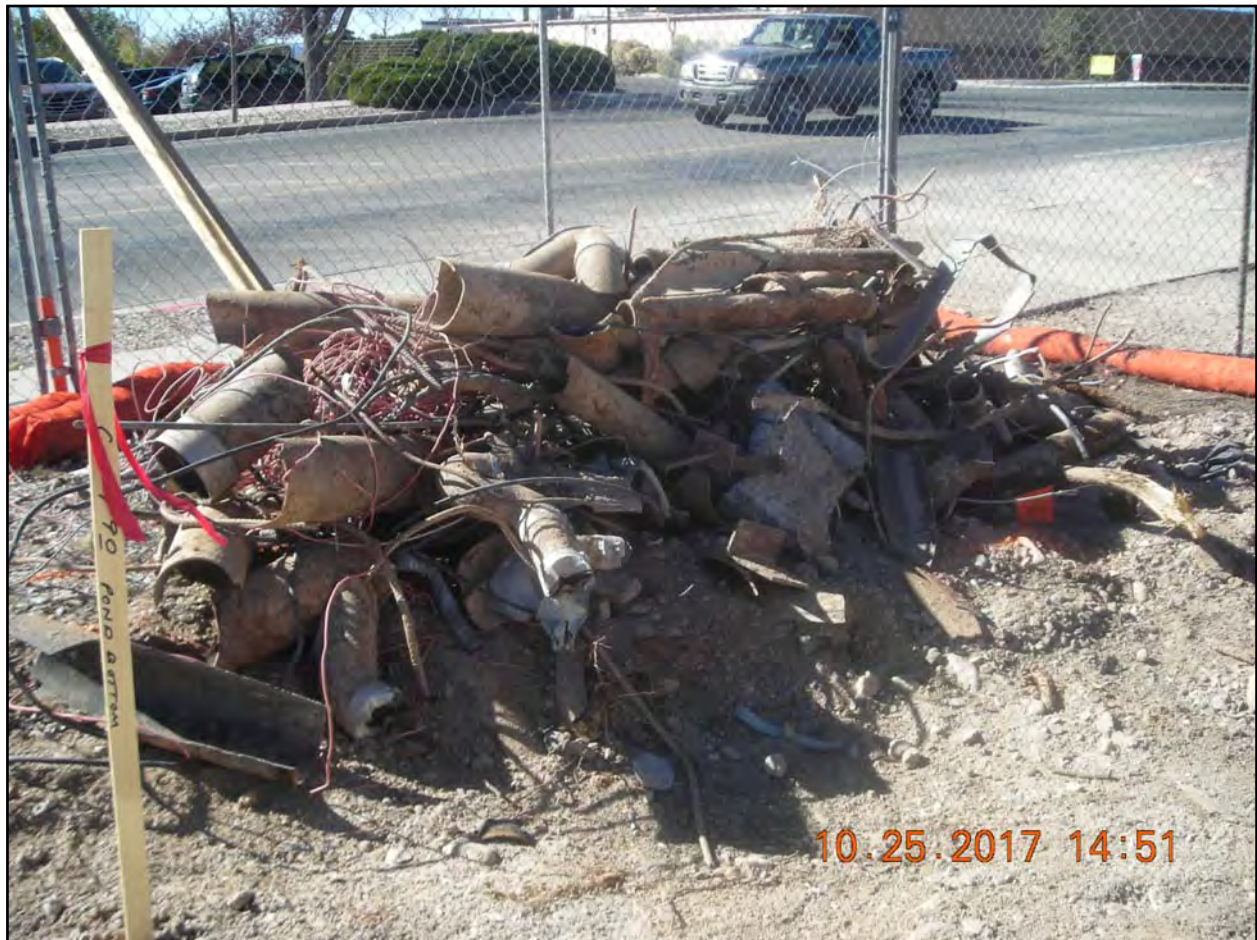
Photo # 1

Photographer: J. Foote	Date: 10-25-17	Time: 1451 hours
City/County: Santa Fe, Santa Fe County		
Location: Morningstar of Santa Fe, 2041 S. Pacheco St.		
Subject: Piled trash on ground at the site. Permittee representative indicated that it would be removed by the next day.

- On the day of the inspection, there was not a dumpster present to collect construction wastes, but the permittee representative indicated that there would be one as early as next week. Construction trash was piled on the ground, or in makeshift pallet containers.

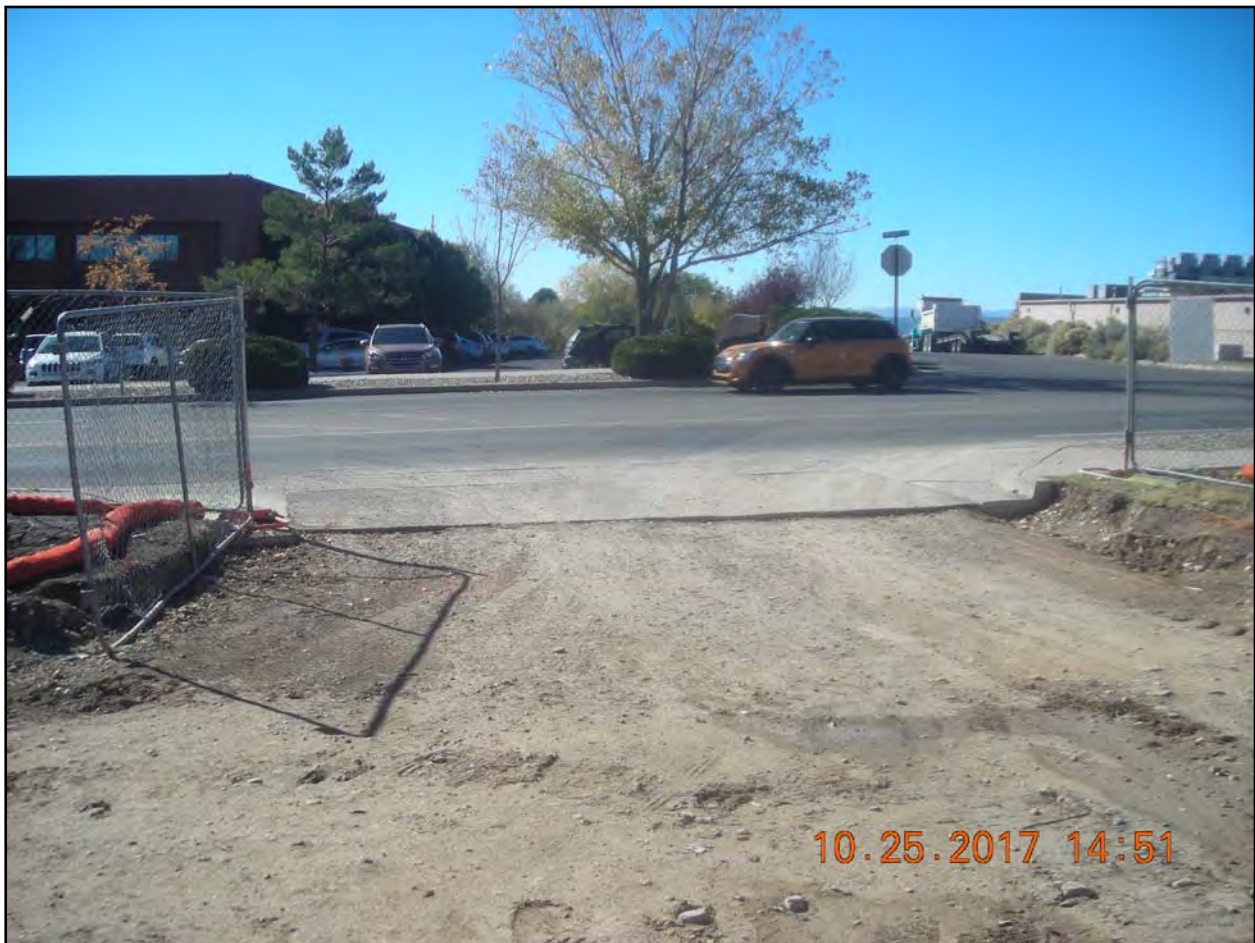
Photo # 2

Photographer: J. Foote	Date: 10-25-17	Time: 1451 hours
City/County: Santa Fe, Santa Fe County		
Location: Morningstar of Santa Fe, 2041 S. Pacheco St.		
Subject: Slight trackout observed from the designated entrance to the construction site.

- At the time of the inspection, two construction entrances existed. One, with a stabilized apron, was considered the exit for trackout purposes, and the other was considered the entrance and was not stabilized. Construction personnel were using the entrance for an exit.

- Mulch socks were installed around the downstream perimeter of the site, and were stabilized with sand bags. Stakes were not practical due to the presence of shallow utilities at 12-18”.
- Stockpiled rocks and sediment were present on site and were being included in the dust control/water application, but no additional BMPs around the dirt stockpile were being employed at the time of this inspection.
- Storm drain on Pacheco Street not protected.
- Fueling occurs on site and there is no spill kit available in the event of an accidental release.
- Port-o-lets present on site were not staked down/secure at the time of this inspection.
- Slight trackout from the site was observed on Pacheco Street.

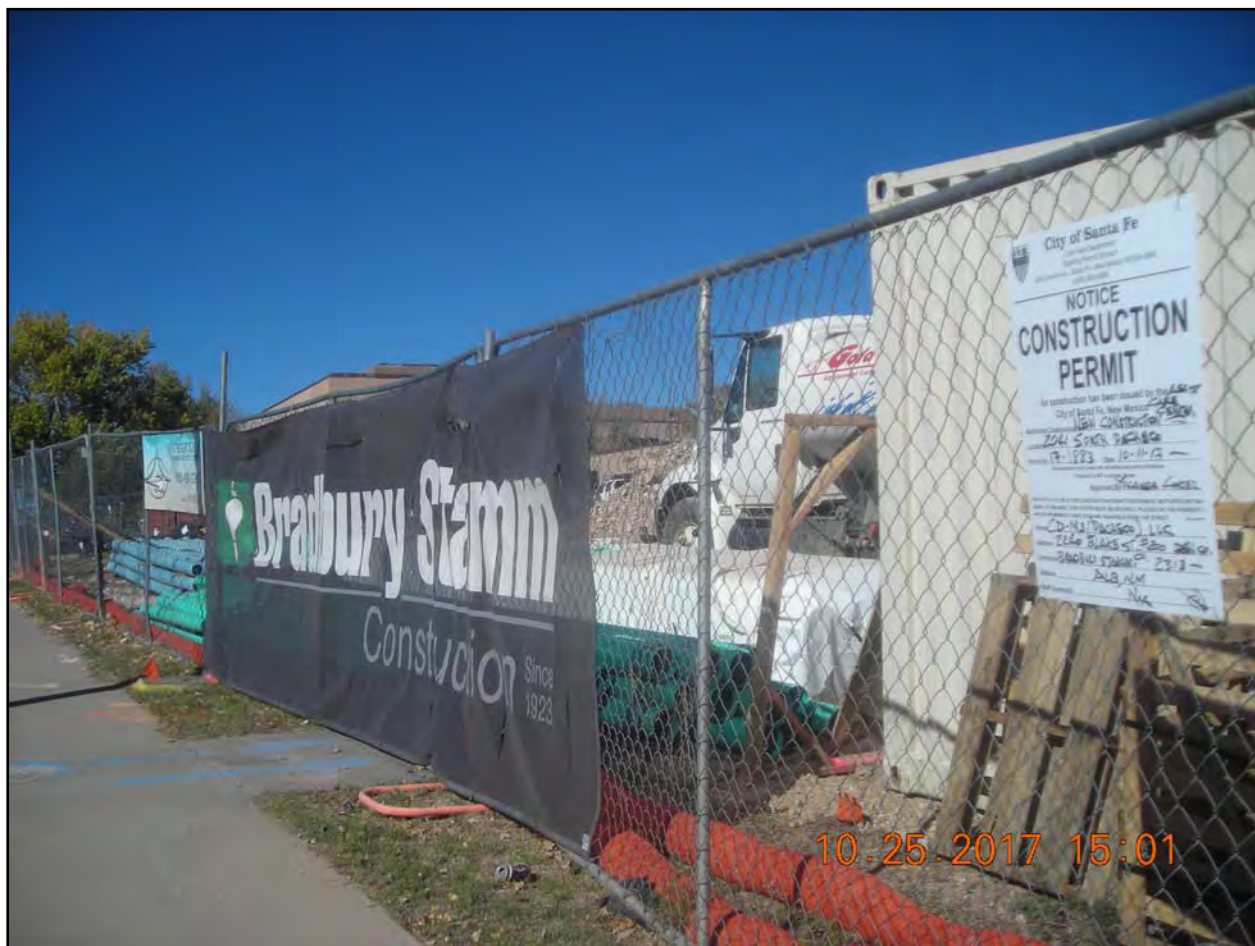
Photo # 3

Photographer: J. Foote	Date: 10-25-17	Time: 1501 hours
City/County: Santa Fe, Santa Fe County		
Location: Morningstar of Santa Fe, 2041 S. Pacheco St.		
Subject: Signage available to the public on the day of the inspection.

- The owner/operator both did not post the publicly accessible NOI information on the day of the inspection.
- Although the NOI documented eligibility for the permit under Criterion A for Endangered Species Act purposes, the only documentation present in the SWPPP was a general list of species present in Santa Fe County. No documentation was present to confirm that the owner or operator had used the process outlined in Appendix D of the permit (the ECOS process should result in a printable document).
